**NASA**  
**RL10 IGNITION LIMITS TEST  
FOR SHUTTLE CENTAUR**

**FINAL REPORT**

**CONTRACT NAS3-22902**

**Prepared by  
United Technologies Corporation  
Pratt & Whitney  
Government Products Division  
P.O. Box 109600, West Palm Beach, Florida 33410-9600**

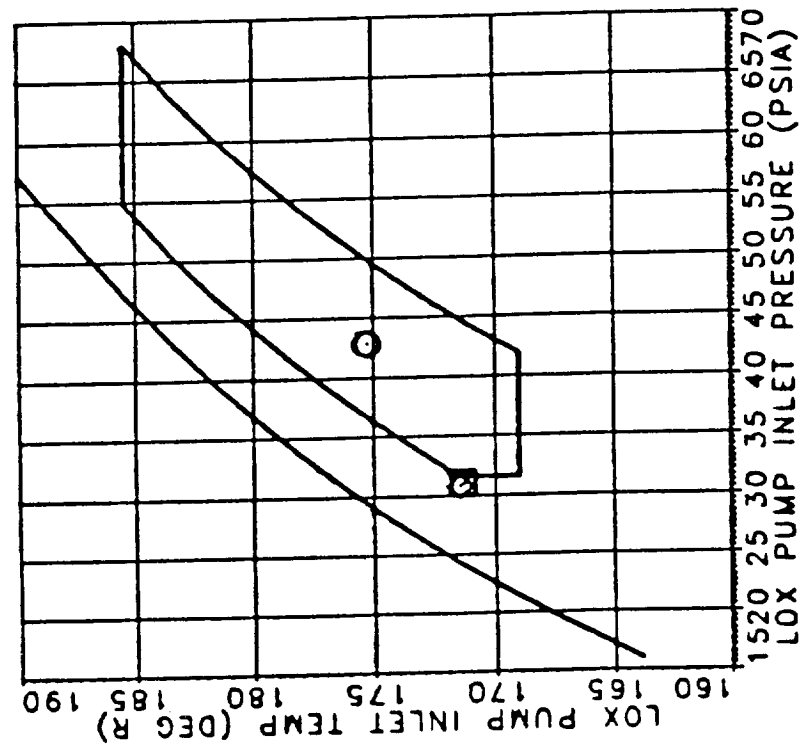
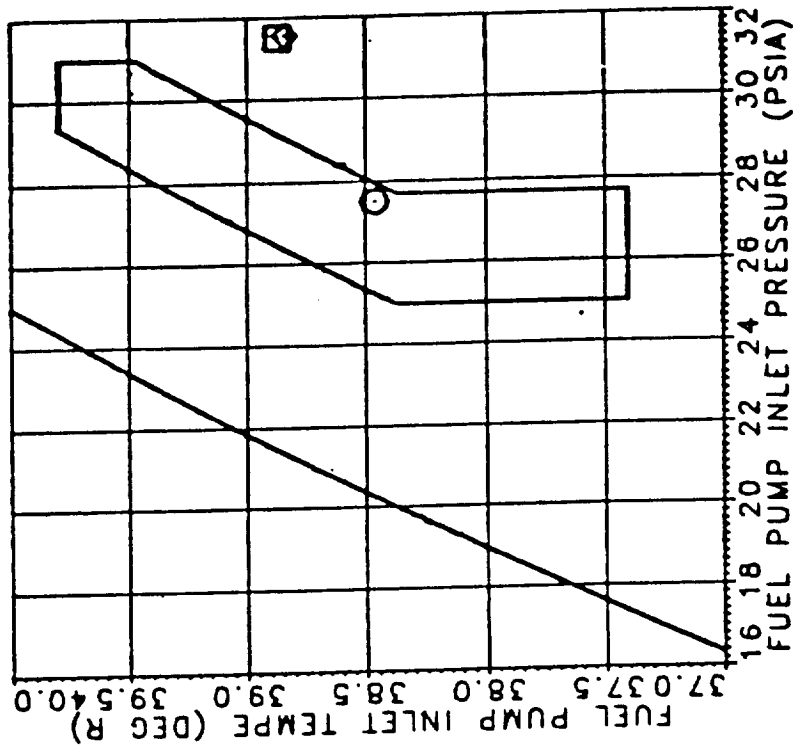
Figure 1. Engine Conditions at Which No-Lights Occurred

The Shuttle/Centaur ignition investigation was originally prompted by three no-lights during Shuttle/Centaur RL10A-3-3B testing. Figure 1 shows the engines and conditions at which these no-lights occurred. To investigate these occurrences, an ignition investigation was run on engine XR105-3 (runs 35-41). This study concluded that the igniter mixture ratio needed to be increased to ensure that the igniter was within the ignition range. Also, the need for conducting tests with evacuated cooldown valves was demonstrated. (Note: During Centaur operation the RL10 cooldown valves discharge to high altitude vacuum during the cooldown. This process is simulated during ground test by "evacuating" the cooldown valve discharge system with a steam ejector. This process is not routinely used due to the potential for contaminating the engine with water from the steam system and also due to steam consumption. It is utilized when required for special tests). Start transients with evacuated cooldown valves were shown to have a lower unlit chamber pressure, and slightly higher oxidizer/fuel (O/F) mixture ratio, than those with non-evacuated cooldown valves. Hence, it is possible to be within the ignition region with non-evacuated cooldown valves and out of it with evacuated valves. Appendix C gives more details of the XR105-3 testing along with a summary of the runs made. This test series was concluded prematurely by water contamination of the engine, however, the need for further testing was apparent. Therefore, engine XR103-3 was run to investigate igniter oxidizer plumbing schemes and increased igniter oxidizer flow area to increase igniter flow. In the meantime, a hydrogen leakage path was discovered in the igniter. This leakage may add anywhere between 30 percent and 180 percent of the nominal hydrogen orifice area to the total flow area. The leakage areas in the igniters run in XR103-3 were measured so that the actual  $H_2$  flow could be determined.

- THREE NO-LIGHTS ENCOUNTERED WHILE TESTING RL10A-3-3B ENGINES WITHIN THE SHUTTLE/CENTAUR "G" START BOXES
- ALL THREE WERE RELIGHT ATTEMPTS
- EXPERIENCED MANY LIGHTS AT SAME CONDITIONS

1—○—XR103-2 RUN 14.01  
 2—□—XR101-4A RUN 100.01  
 3—○—XR101-4A RUN 110.01

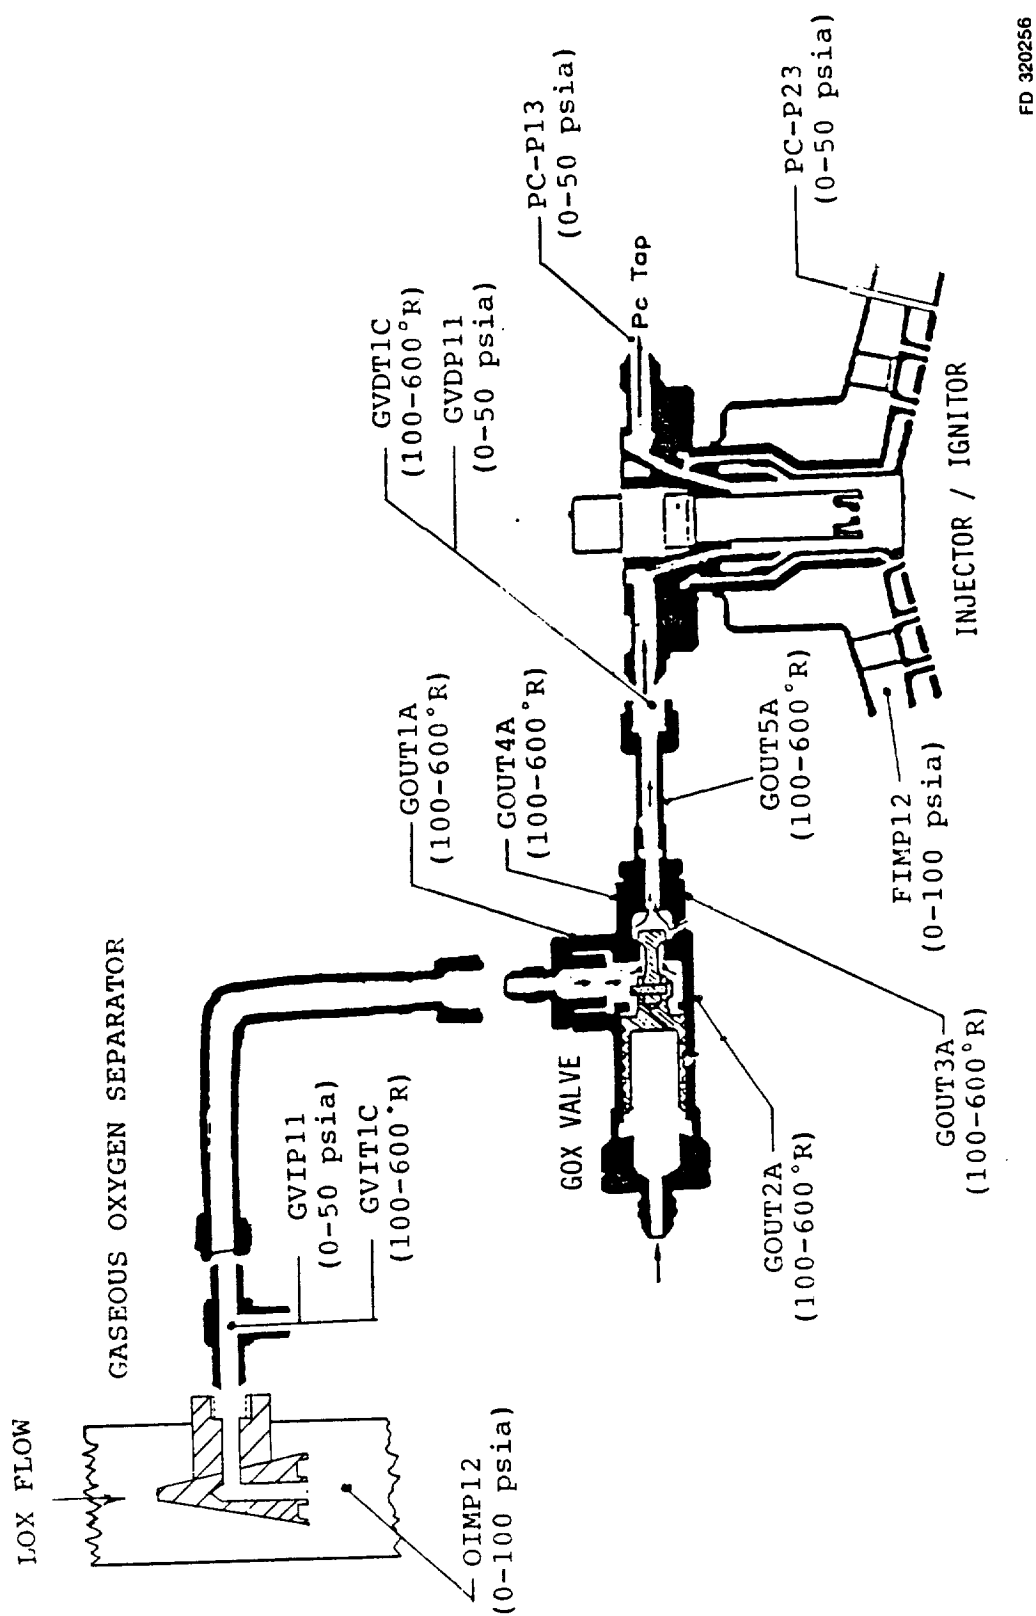
Figure 2. Igniter Study — Special Instrumentation

Special instrumentation was provided to monitor oxidizer pressures and temperatures in the GOX valve plumbing and igniter oxidizer supply lines, as shown in Figure 2. The igniter supply pressure and temperature were used to calculate igniter oxidizer flow. Appendix B outlines the methods used for calculating both chamber propellant flows and igniter flows. Figures 3 and 4 show the igniter/injector geometry and indicate the critical fuel metering holes and the oxidizer orifices. In addition, the location of the leakage gap between the injector sleeve and igniter is pointed out. This leakage can range anywhere from 30 percent to 180 percent of the nominal fuel metering hole area based upon current blueprint tolerances.

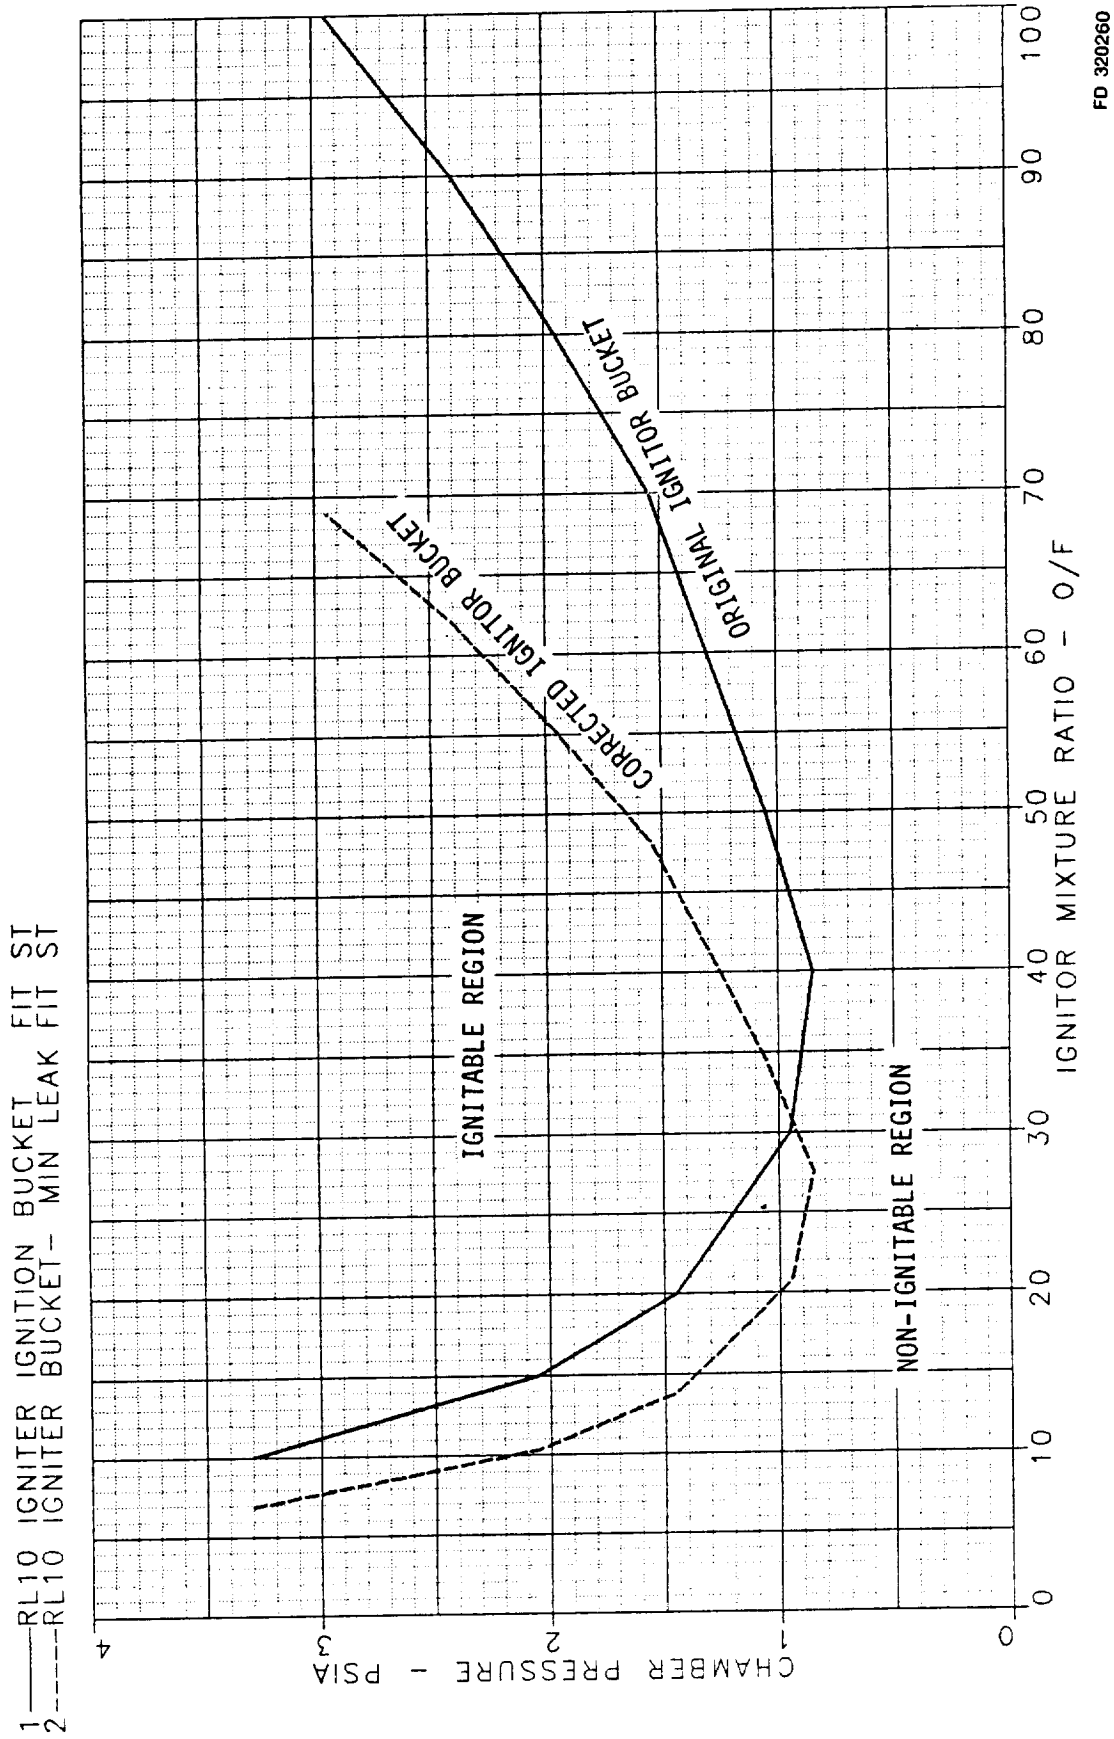
Figure 6. Igniter Bucket Corrected for Minimum  $H_2$  Leakage

Figure 6 shows a plot of the existing igniter bucket (because of the shape of the ignitable region, it is often defined as "bucket"). At the time this was developed, the additional H<sub>2</sub> leakage path in the igniter was not considered, so the H<sub>2</sub> flow used to calculate O/F ratio should be corrected. The actual leakage area in the igniter which was tested is unknown, therefore, the actual amount of correction to be made is uncertain. However, it is certain that at least minimum leakage existed, and since this yields a conservative correction, the curve was corrected by this amount (+30 percent of H<sub>2</sub> flow). This corrected bucket is also shown on Figure 6.

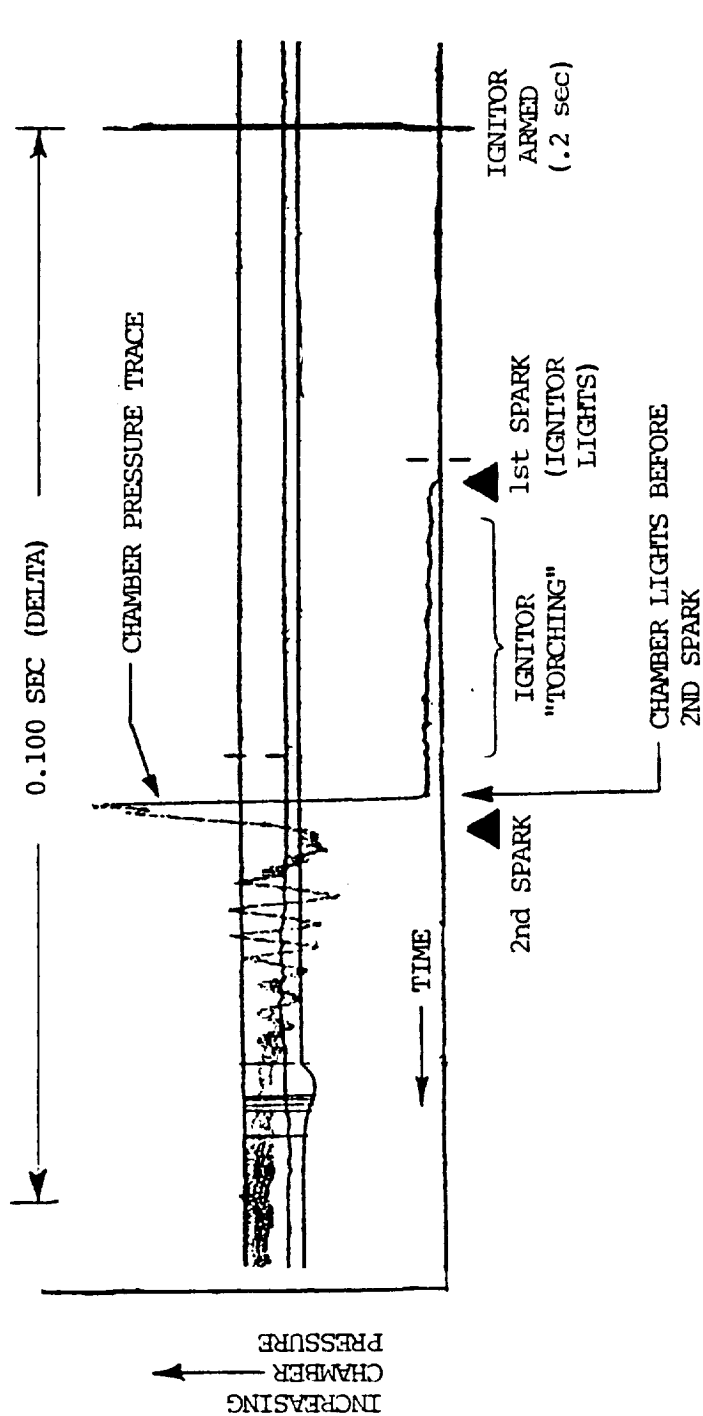
Figure 8. Chamber Pressure Trace for XR103-3 Run 41.01 Showing Igniter Light-Off and Chamber Light

Referring to Table 1, it is seen that in most cases the igniter lit on the first spark and the chamber lit some time later. This phenomenon is referred to as igniter "torching." In many cases the chamber lit between sparks and in run 37, the chamber actually lit at 0.750 second while the igniter was disarmed at 0.700 second. This torching phenomenon is clearly shown by O-graph data. The O-graph trace of chamber pressure ( $P_c$ ) for run 41 is shown in Figure 8. A small jump in  $P_c$  occurs at the first spark indicating that the igniter has lit. The igniter then torches until the chamber lights, indicated by the large jump in  $P_c$ . Note that the chamber lights before the second spark. In other runs, the igniter torches for many sparks before the chamber lit. The reason that the igniter can torch without chamber ignition, even though the chamber is within its ignition bucket, may be explained by Figure 9. The igniter torches up near the fuel and oxidizer metering holes. Leakage hydrogen mixes with the combustion products nearer the tip of the igniter and dilutes the gases before entering the chamber. Ignition does not occur until sufficient energy is present in the combustion products.

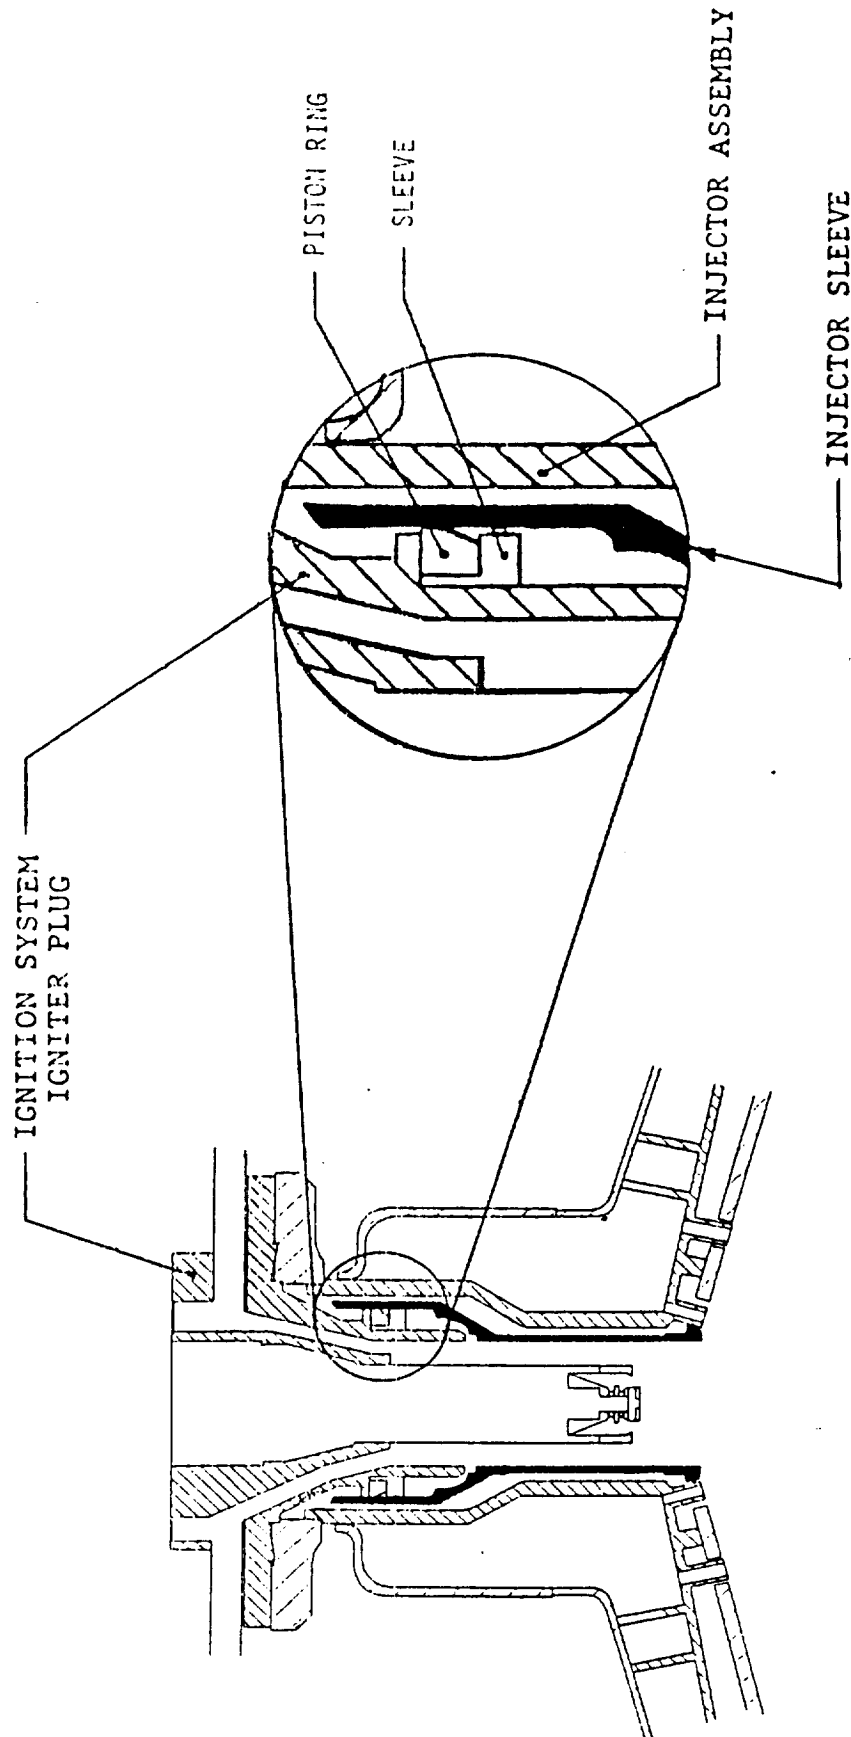
Figure 10. RL10 Igniter Leakage Control — Proposed Configuration Piston Ring Design Provides Controlled Leakage

Hydrogen leakage in the igniter can be significant and can adversely affect the igniter O/F mixture ratio to the point of delaying ignition significantly. However, indications are that unlit engines tend to move with time toward favorable ignition conditions so that ignition will occur in most all cases, although some delay may occur. To avoid the possibility of excessive hydrogen leakage, a leakage control scheme should be implemented. The leakage should not be eliminated entirely, as it has always existed and igniter performance and durability has historically been good, but should be held to the minimum level that currently exists. One possible scheme to do this is shown in Figure 10. This piston ring arrangement would provide a positive seal between the igniter and the injector sleeve and may contain slots for controlled leakage. This arrangement is a concept only and no detailed design has been performed at this point.

- A hydrogen leakage path in the igniter, which has been overlooked in previous ignition investigations, has been identified. The injector/igniter clearance gap (minimum 0.0005 in., maximum 0.002 in.) creates  $H_2$  leakage between 30 percent and 180 percent of the nominal flow through the igniter fuel holes. Incorporation of a seal to control this leakage to the 30 percent level is recommended.

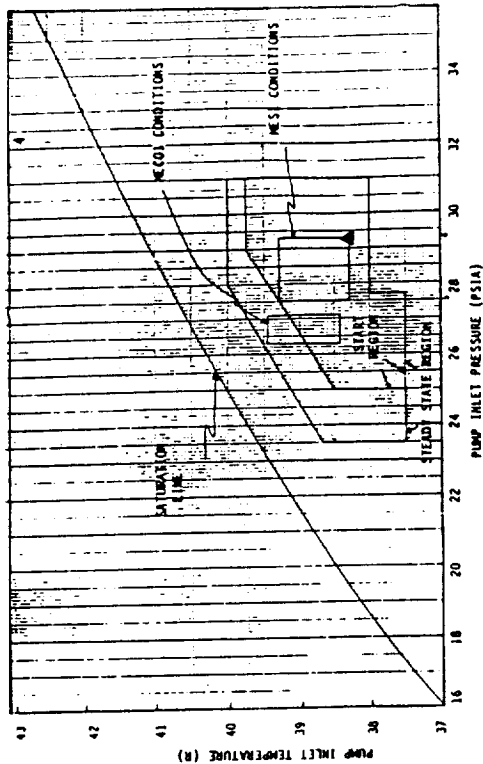
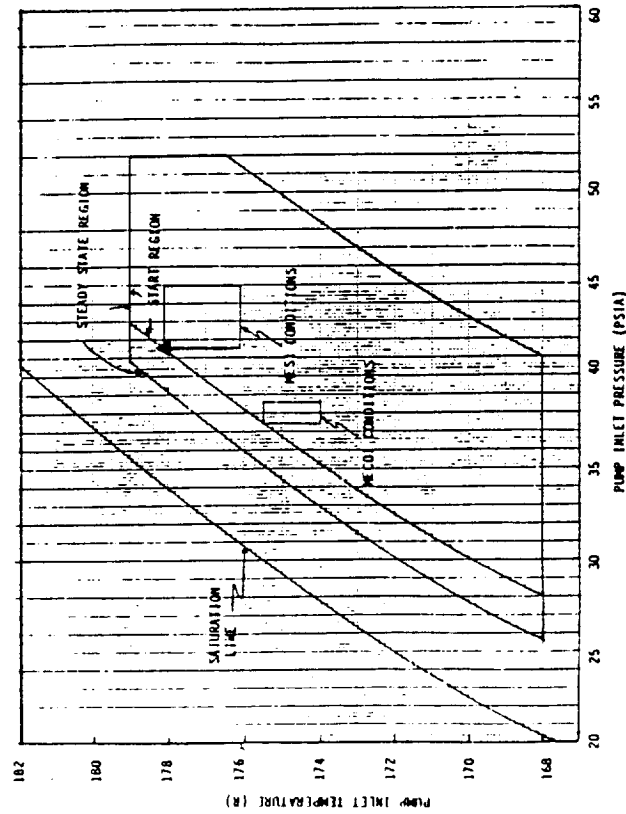
Figure 12. AC-66 Inlet Conditions — First and Second Starts (Sheet 1 of 2)

An ignition study was done for Atlas/Centaur launch No. 66 (AC-66) using the predicted inlet conditions. The worst case inlet conditions were used for both starts as shown in Figure 12. The igniter conditions were predicted using an RL10 transient start simulation program. The results are illustrated in Figure 13. The top two figures show igniter conditions assuming nominal igniter flow areas and nominal leakage size (0.00125 in. gap) with the worst case inlet conditions (Figure 12). These conditions would be those normally expected, and as shown, the igniter is well within the ignitable region for most of the transient. The bottom two plots show what happens if all worst case tolerances are considered (maximum  $H_2$  area and minimum  $O_2$  area) along with the largest leakage area and worst inlet conditions. The igniter is still within the ignition bucket during the initial part of the transient, when ignition should occur, but does move out of the bucket at about 0.22 second.

## ▲ WORST CASE FIRST START CONDITIONS

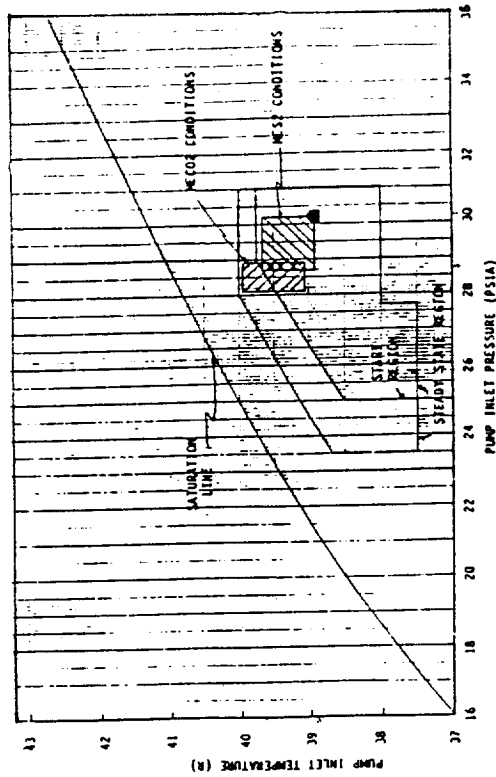
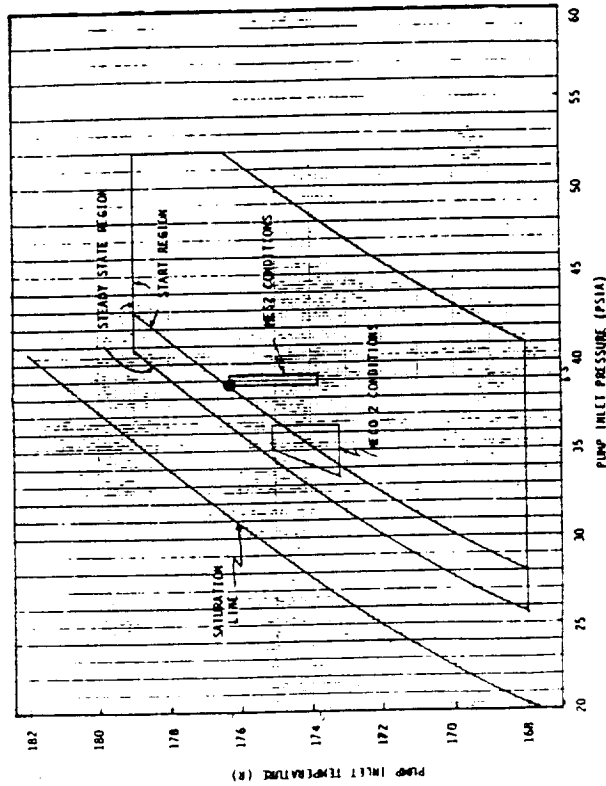
Figure 12. AC-66 Inlet Conditions — First and Second Starts (Sheet 2 of 2)

## WORST CASE SECOND START CONDITIONS

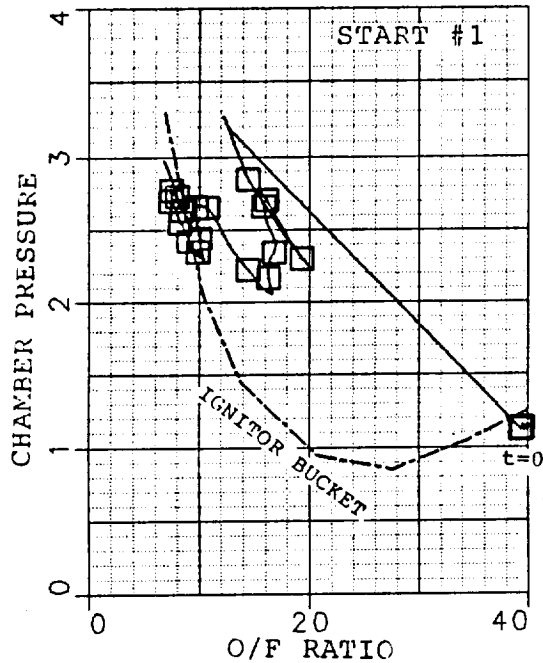
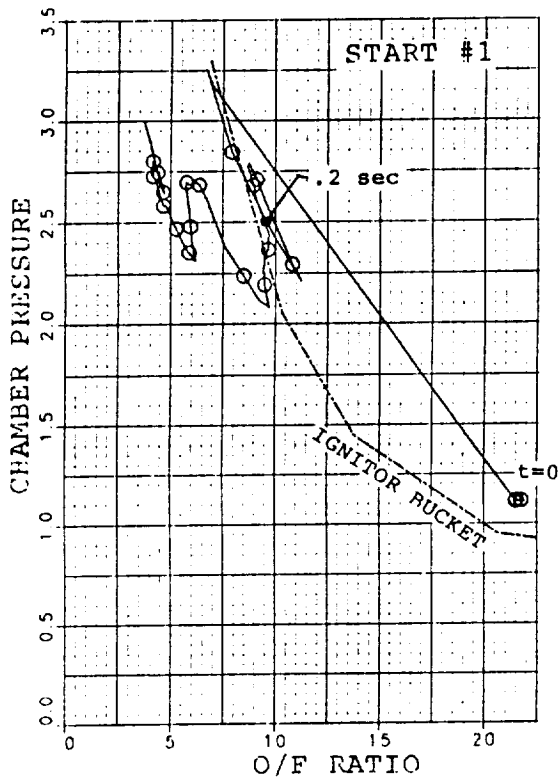
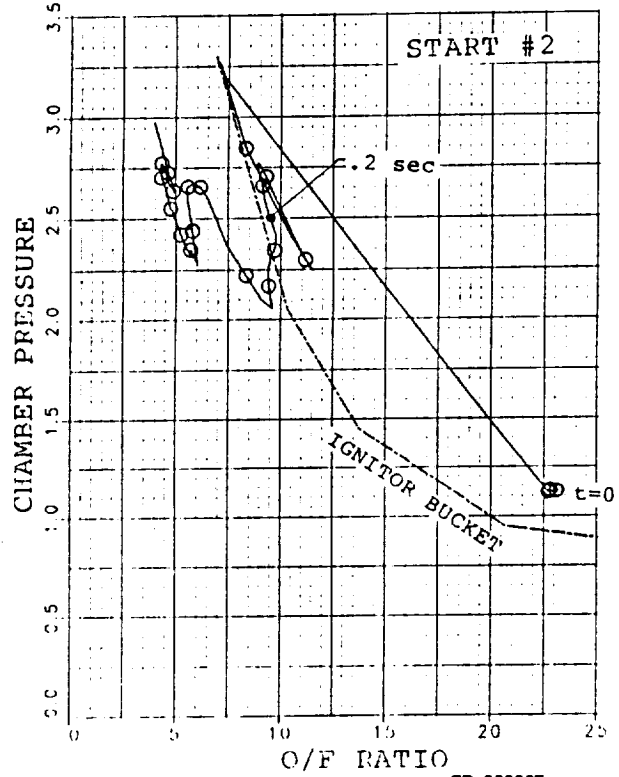
Figure 13. AC-66 Predicted Igniter Conditions

## NOMINAL IGNITOR AREAS &amp; NOMINAL LEAKAGE AREA:

## WORST CASE IGNITOR AREAS &amp; LARGEST LEAKAGE:

- Start transient modeling for Atlas/Centaur shows that if an igniter with worst case leakage is combined with the worst case Atlas/Centaur specification inlet conditions (low LOX pressure, high fuel pressure), the igniter mixture ratio will be out of the start bucket. The possibility of this situation, even though unlikely, makes fuel leakage control mandatory for the full range of Atlas/Centaur specification inlet conditions. Until incorporation of this control the vehicle propellant inlet condition range must be limited.
